Smoke and Dye Testing Summary

High Level Sewershed

Test ID	Test Type	Date Inspected	Company / Super.	Blower MH	Ground Condition	Notification Made?	Total Length
S1028-030	Smoke	8/18/2008	ADS/TM	S11WW_016MH	Dry	Yes	1,443.49

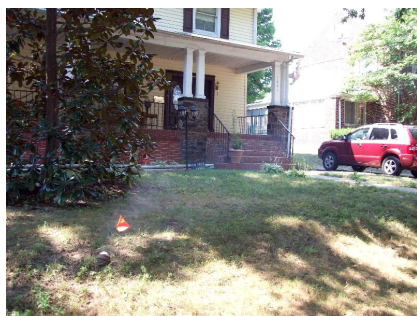
Picture \S1028-030-OB03-P01.jpg

Comments Smoke from cleanout in font yard. 3406 Ellamont Rd.

Comments Front of house, 3406 Ellamont Rd.
